**FUEL DYNAMICS LOSS-OF-FLOW TEST L3  
(FINAL REPORT)**

**A. K. Fischer, R. K. Lo,  
and E. W. Barts**

**ARGONNE NATIONAL LABORATORY, ARGONNE, ILLINOIS**

June 1976

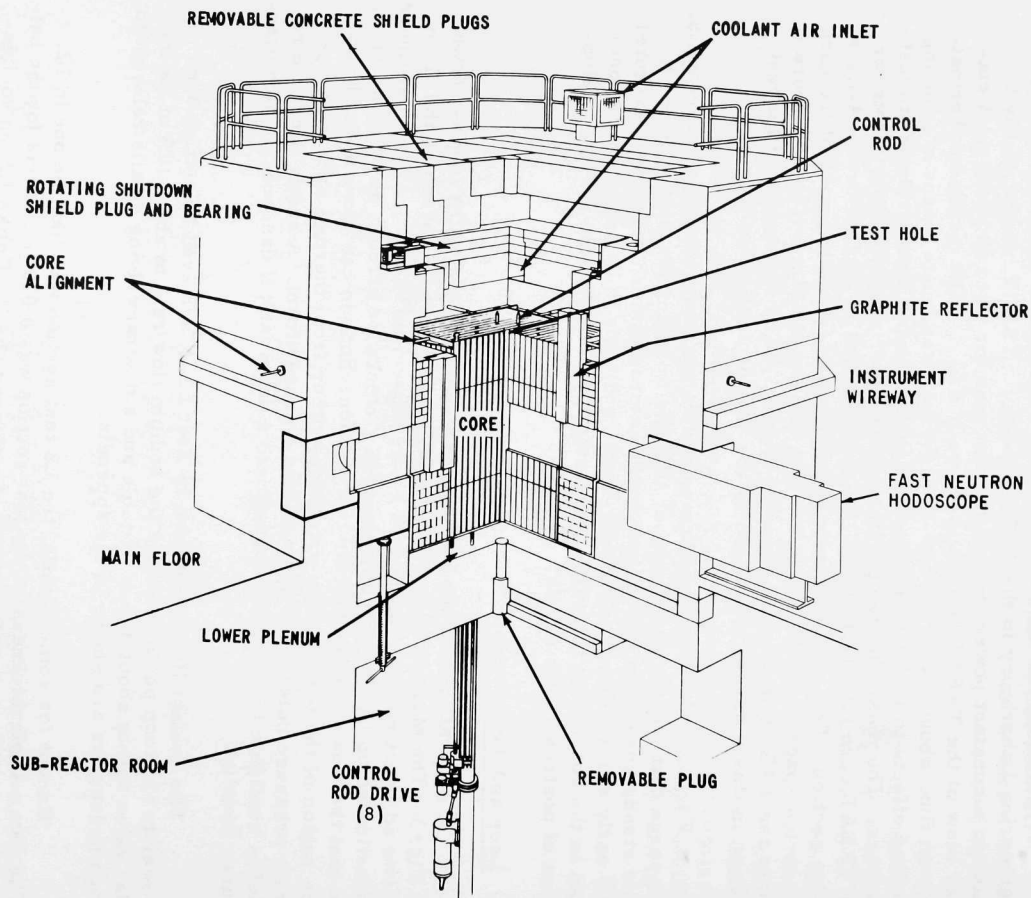
Fig. 1. Cutaway View of TREAT Facility. ANL Neg. No. 900-2776.

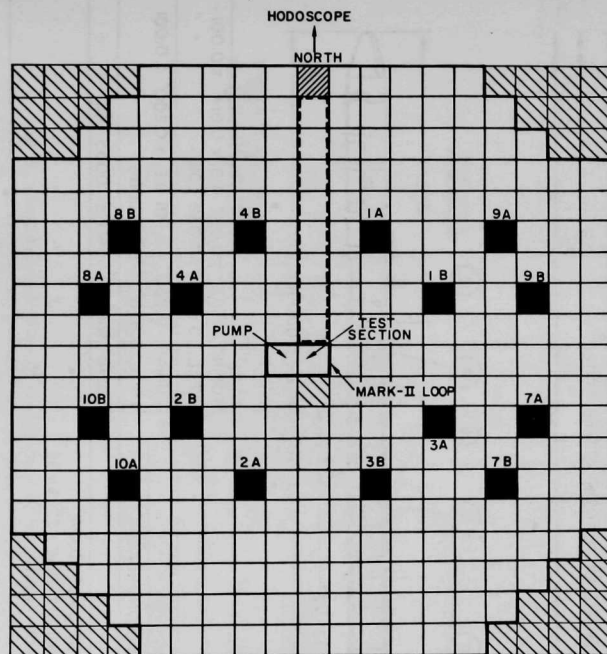
Fig. 2. TREAT Core-loading Diagram for Test L3.  
ANL Neg. No. 900-3591 Rev. 1.

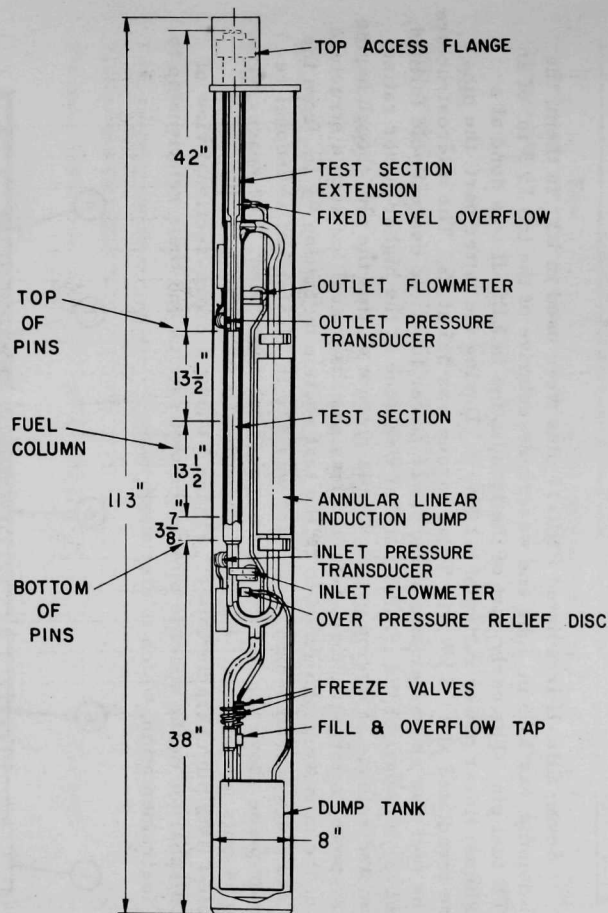
Fig. 3. General View of Test Section and Mark-IIA Loop.  
ANL Neg. No. 900-2777.

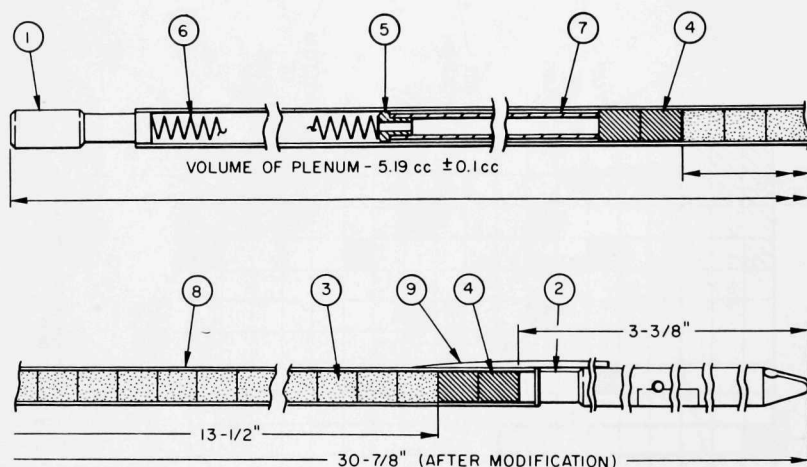
1	END PLUG (TOP)	7	TUBING, 0.187" $\pm$ 0.002 O.D. $\times$ 0.014" $\pm$ 0.001 WALL, 5.937" $\pm$ 0.032 LONG
2	END PLUG (BOTTOM)	8	TUBING, 0.230" $\pm$ 0.001 O.D. $\times$ 0.200" $\pm$ 0.001 I.D. $\times$ 26.875" $\pm$ 0.016 LONG
3	FUEL	9	SOLID WIRE 0.0540" $\pm$ 0.0005 DIA.
4	INSULATOR PELLETS 0.25 LONG (EACH)		
5	SPACER CAP		
6	SPRING, COMPRESSION, 112 COILS, 0.194" $\pm$ 0.002 O.D., 0.025" $\pm$ 0.001 DIA. WIRE, 7" $\pm$ 1/32 FREE LENGTH, GRIND ENDS SQUARE.

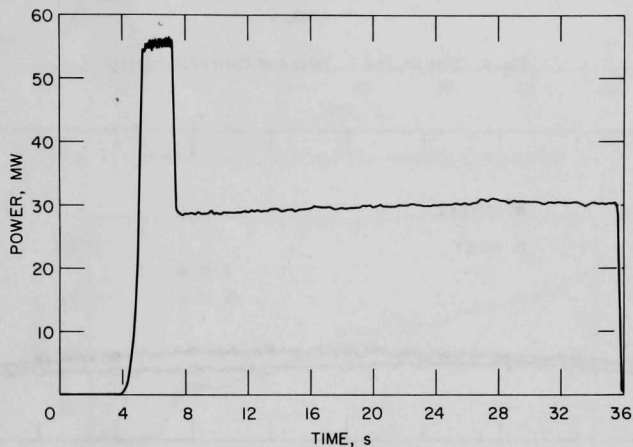
Fig. 7. Test L3, Run 1: Reactor Power

Two runs comprised Test L3. The first run, designated L3-1 or L3-Run 1, was TREAT transient number 1482 and was performed on December 21, 1972, at 1228 hours. Test L3-1 was performed with a reactor power transient, described in Fig. 7, but without a flow coastdown. Other data for L3-1 are presented in Figs. 8-15.

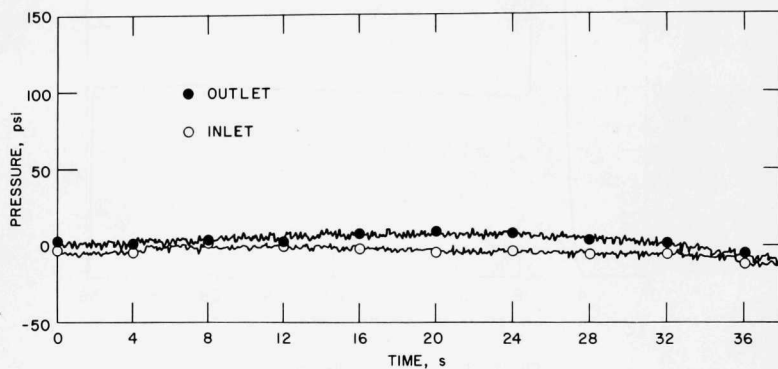
Fig. 10. Test L3, Run 1: Inlet and Outlet Coolant Pressure

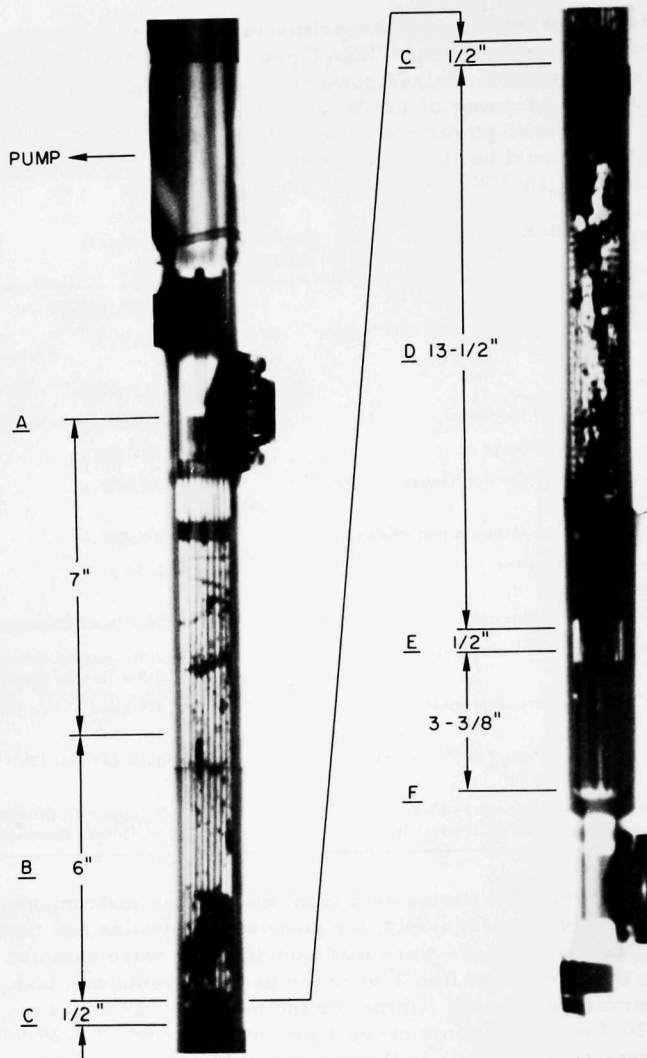
A - TOP OF PINS  
 B - SPACER TUBE  
 C, E - INSULATOR PELLETS

Figure 35 shows the posttest neutron radiographs of the test-section side of the stripped loop. The most prominent features of these radiographs are (1) the extensive removal of fuel from the midregion of the column and

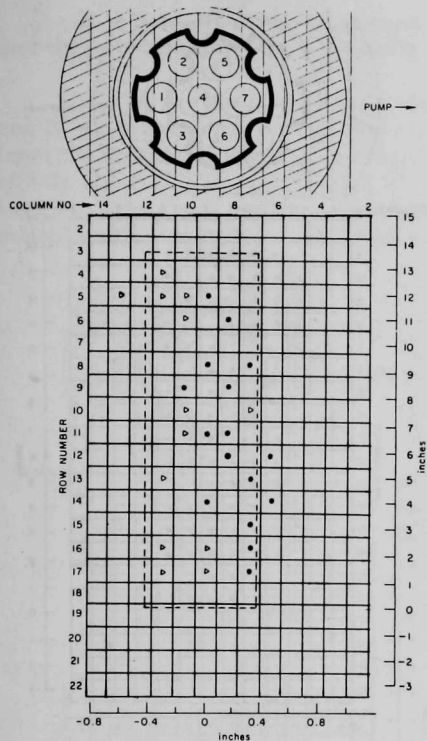
Fig. 38. Test L3 Fuel Configuration at 15 s with Respect to 8-s Configuration

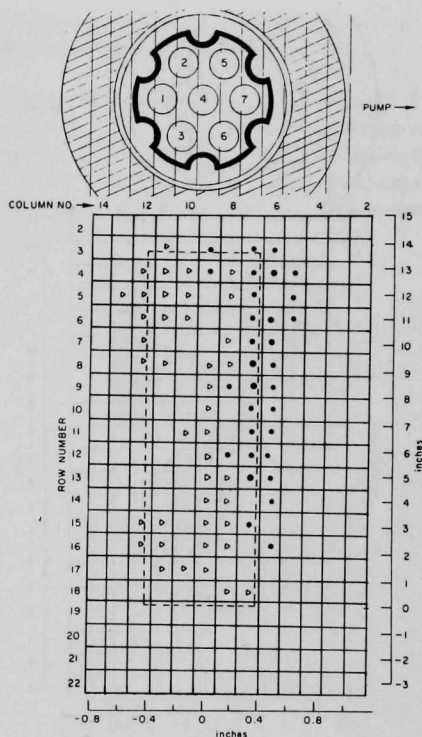
Fig. 39. Test L3 Fuel Configuration at 17.5 s with Respect to 8-s Configuration

15-17.5 s. At about 15 s, fuel motion toward the pump started again, but with less coherence. Figure 39 shows that the greatest motion was in the top third of the fuel column, the portions of pins 1-3 in the middle third of the fuel column showing very little motion. Pins 4-7 had crowded against the fluted tube, except at the bottom. By 17.5 s, some upward fuel motion had occurred, as though the overall amount of fuel in the bottom third had decreased by about 3-5%. Anticipating the scenario that is presented later in this report, we note that this interval covers the start of boiling, the start of cladding dryout, and the start of cladding melting, as predicted by SAS.

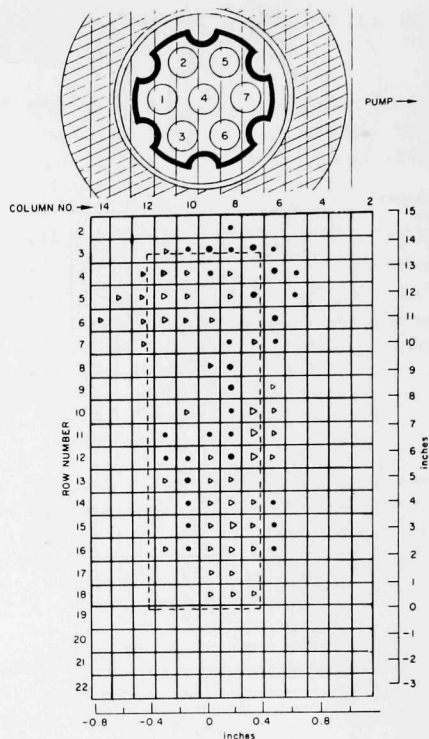
Fig. 41. Test L3 Fuel Configuration at 20.5 s  
with Respect to 8-s Configuration

The situation at 20.5 s is shown in Fig. 41. A persistent feature up to this time was a depletion by 20-30% of the fuel in the upper corner away from the pump. The top quarter of the fuel column evidently remained displaced toward the pump.

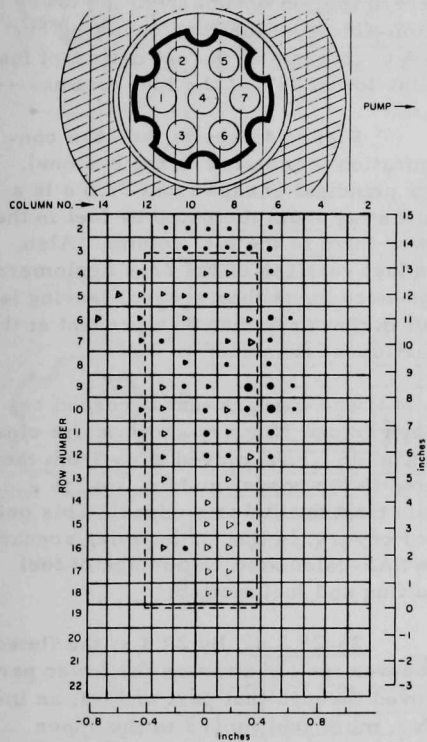
Fig. 42. Test L3 Fuel Configuration at 22 s with Respect to 8-s Configuration

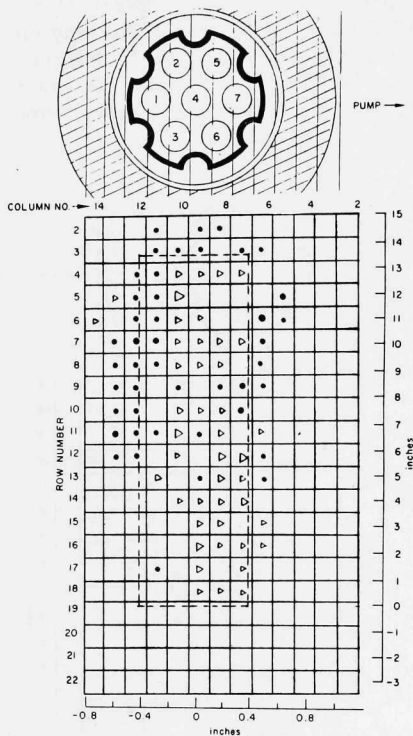
Fig. 44. Test L3 Fuel Configuration at 23.5 s with Respect to 8-s Configuration

22-26 s. The midplane agglomeration at 22 s did not last long, having largely disappeared by 23.5 s, as shown by Fig. 44. Comparison of Figs. 42

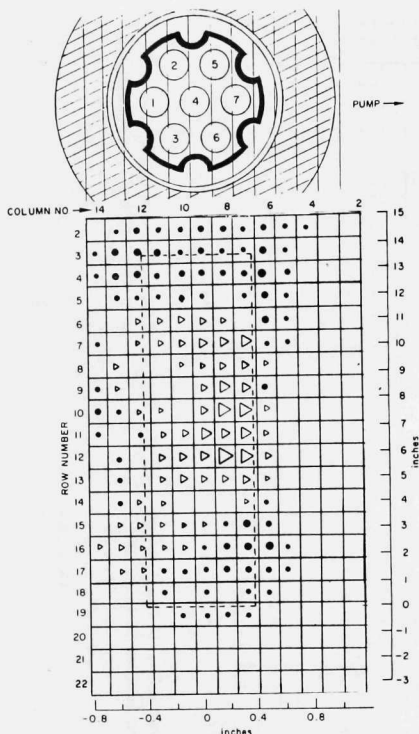
Fig. 48. Change in Test L3 Fuel Configuration due to Eruption between 29.72 and 29.98 s

Eruption at 29.8 s. A sudden voiding of the central region of the fuel began at 29.75 s and was largely completed within 150 ms. Figure 48 shows the change in the 260-ms interval between 29.72 and 29.98 s. Most of the fuel motion was upward, with  $10 \pm 2\%$  of the fuel disappearing above the viewing

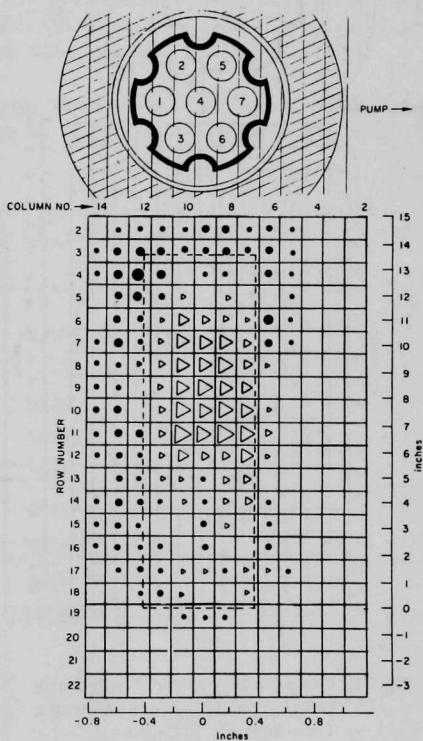
Fig. 50. Test L3 Fuel Configuration at 30.5 s with Respect to 8-s Configuration

Figure 50 shows the situation shortly after the eructation, at 30.5 s, with respect to the 8-s configuration. Much of the region originally occupied by the fuel was almost completely voided. Up to this point there was only a relatively small amount of downward motion of the fuel, resulting in some accumulation at the lower part of the side away from the pump.

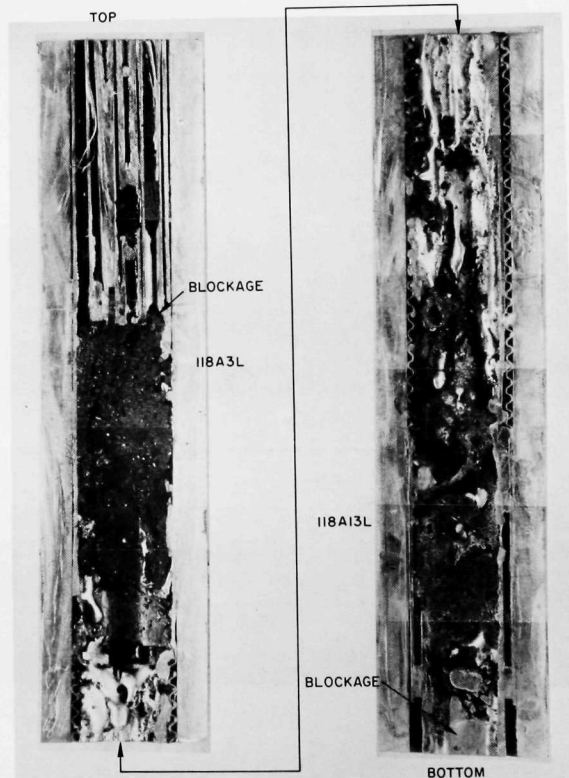
Fig. 57. Mirror Images of Sections 118A3L and 118A13L after Sodium Removal, Showing Blockages at Bottom of Elements at Lower Right and above Fuel Mass at Upper Left. Mag. ~0.6X. Neg. No. MSD-168948.

An irregular melted stainless steel blockage, varying in apparent thickness from  $1/16$  to  $1/2$  in., was found just above the original top of the fuel column. Transverse sections through the region are shown in Figs. 65 and 66. Below the stainless steel, porous melted fuel contributed to the blockage for about 1.25 in. Above the stainless steel, an obstruction of lightly sintered fuel and globules of stainless steel was found. This obstruction did not fill the spaces around the elements. Lightly sintered fuel and globules of metal were also found inside the spacer tubes. Two elements, PNL-17-31 and -15, had melted locally through their cladding (see Figs. 57 and 58) above the

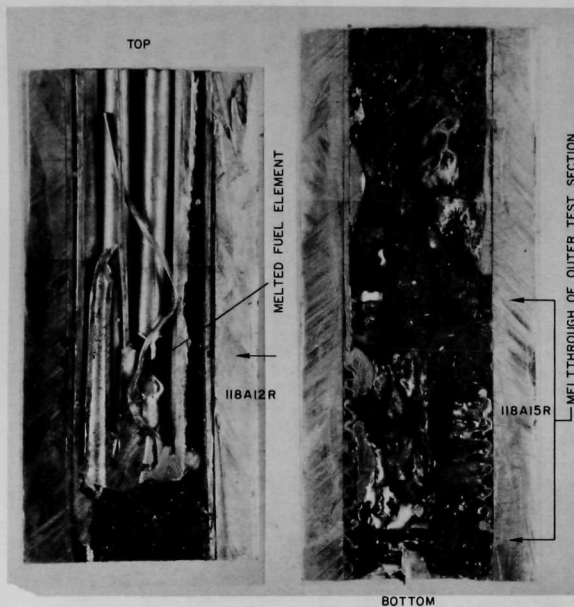
Fig. 58. Mirror Images of Sections 118A12R and 118A15R after Sodium Removal, Showing Melting of Elements 17-15 above Fuel Column and Meltthrough of Outer Test-section Tube. Mag.  $\sim 0.9X$ . Neg. No. MSD-169066.

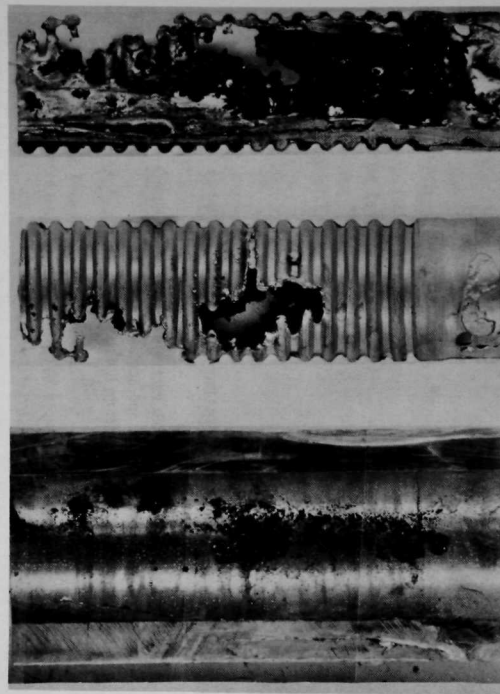
Fig. 59. Mirror Images of Section 118A17R after Sodium Removal, Showing Front and Back Views of Bellows and Inside of Loop Wall at Mid-length of Original Fuel Region. Mag.  $\sim 0.9X$ . Neg. No. MSD-169063.

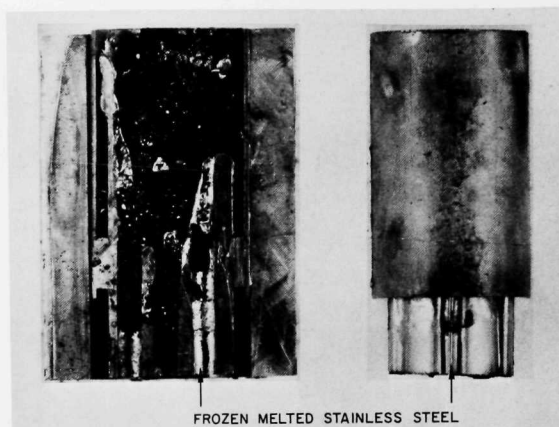
Fig. 60. Mirror Image of Section 118A19R after Sodium Removal, Showing Bottom Blockage (left) and Backside of Test-section Tube after Separation from Loop Wall. Mag.  $\sim 0.9X$ . Neg. No. MSD-169065.

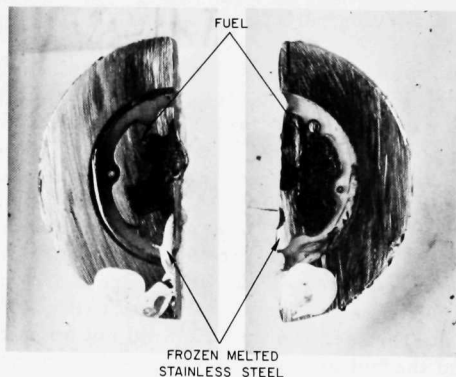
Fig. 62

Mirror Images of Transverse Sections from Vicinity of Bottom Blockage below Header. Mag. ~1X. Neg. Nos. MSD-166882 and -166883.

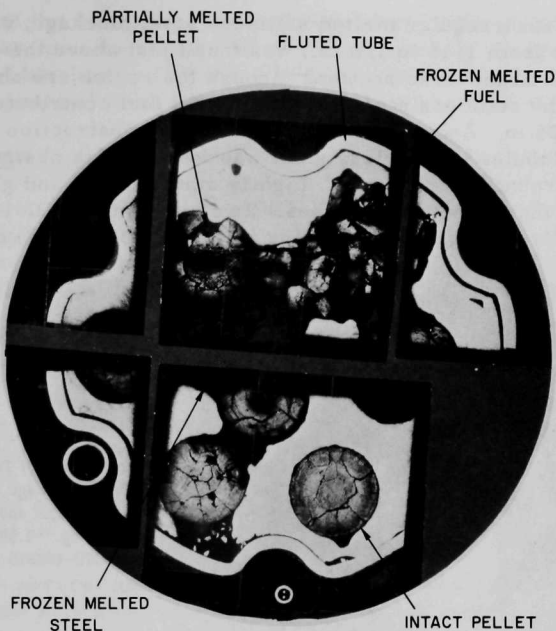
Fig. 63. Composite of Transverse Sections through Bottom Blockage, Showing Distribution of Fuel and Melted Stainless Steel. Mag.  $\sim 3.25X$ . Neg. No. 169143.

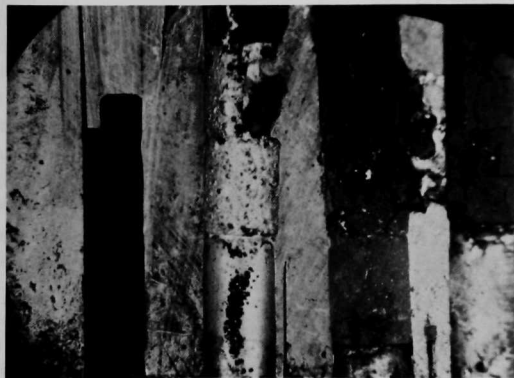
Fig. 64

Bottom of Fuel Column, Showing Stainless Steel Blockage; Section 118A19R. Mag.  $\sim 2.75X$ . Neg. No. MSD-169067.

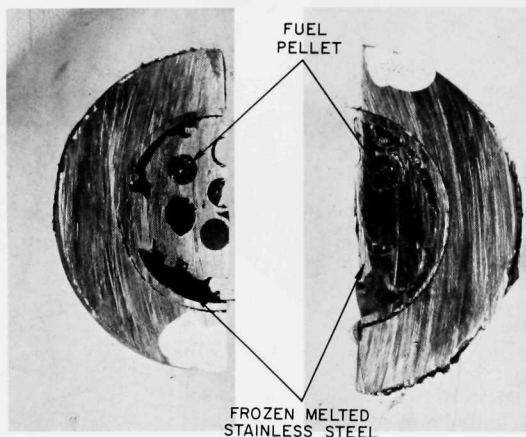
Fig. 65

Mirror Images of Transverse Sections at Upper Blockage, Showing Relationship of Pellets and Melted Stainless Steel. Mag.  $\sim 1.25X$ . Neg. Nos. MSD-166876 and -166879.

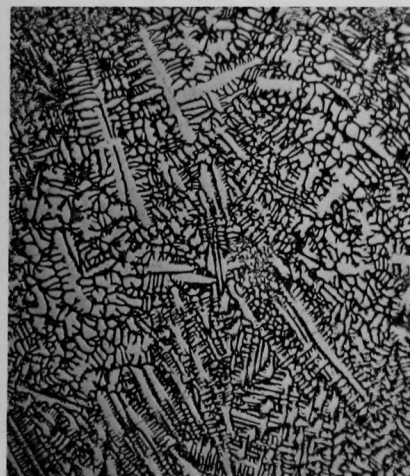
Fig. 67

However, a transverse slice through the tops of the bottom end plugs of the elements (see Fig. 67) showed two principal areas of melted stainless steel that had frozen among the end plugs. One area appeared to be all stainless steel with a cast dendritic structure as shown in Fig. 68. The other area also had a structure, but it included several particles of once-melted fuel, as shown in Fig. 68. The difference in structure between the two patches of steel may be indicative of slower cooling of the steel containing the fuel particles. The steel containing the fuel particles probably came down and solidified later than the other region of solidified steel.

Transverse Section through Top of Bottom End Plugs, Showing Two Types of Melted Material. Mag.  $\sim 5.5X$ . Neg. No. MSD-169064.

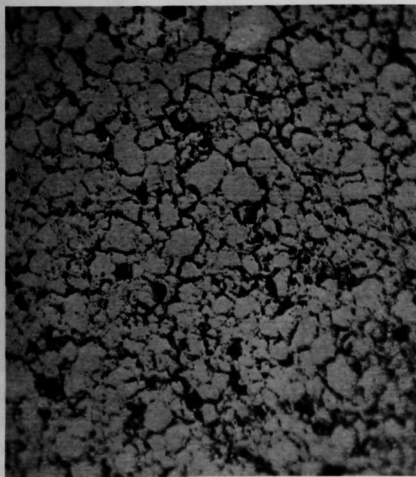
Fig. 70. Melted Fuel with No Metallic Particles  
from Approximate Midlength of Orig-  
inal Fuel Column. Mag.  $\sim 430X$ .  
Etched. Neg. No. MSD-167039.

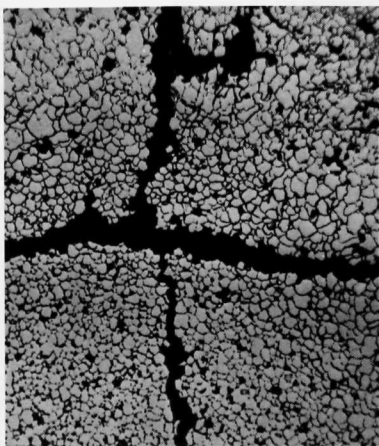
Fig. 72. Cracked, Unmelted Fuel from Bottom Pellet. Mag.  $\sim 80\times$ . Etched. Neg. No. MSD-167079.

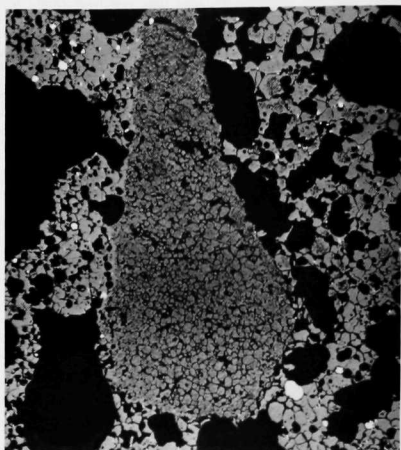
Fig. 73. Grain-size Variation in Upper Fuel Mass. Mag.  $\sim 70\times$ . Etched. Neg. No. MSD-167875.

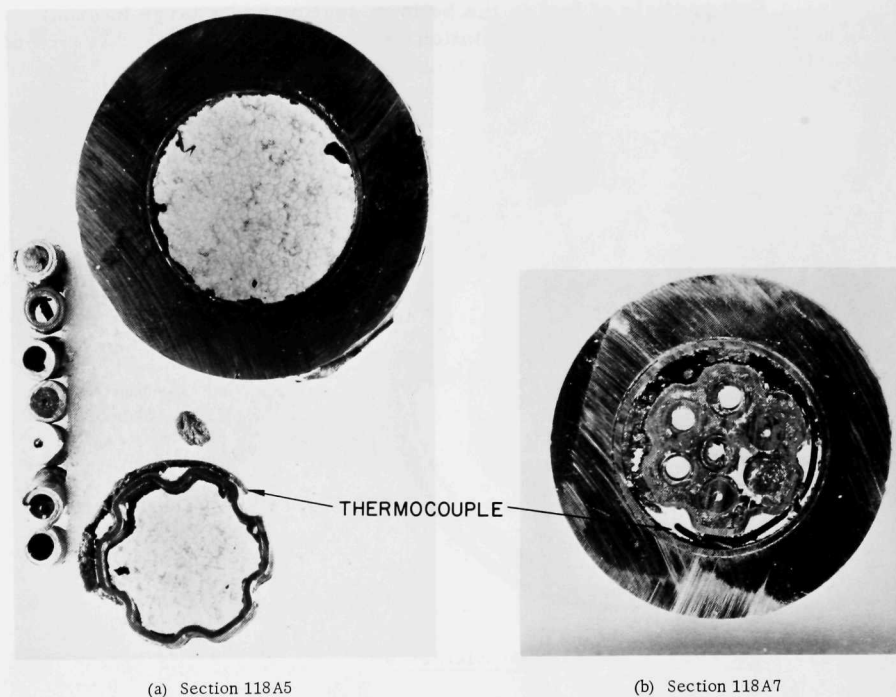
Fig. 76. Fuel Deposited on a Thermocouple between Outer Tube and Inner Fluted Tube. Mag.  $\sim 1.3X$ . Neg. Nos. MSD-166334 and -166339.

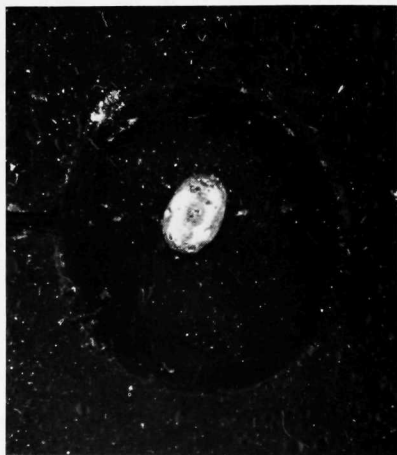
Fig. 77  
Metallic Ingot Recovered from Spacer  
Tube; Section 118A4. Mag.  $\sim 2.4X$ .  
Neg. No. MSD-166919.

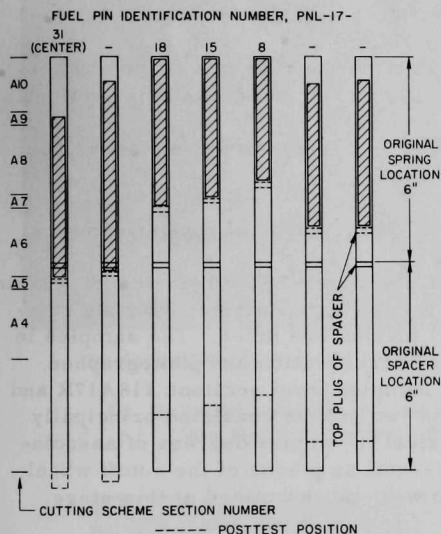
Fig. 78. Relative Pre- and Posttest Locations of Spring and Spacer in Plenums of Fuel Pins

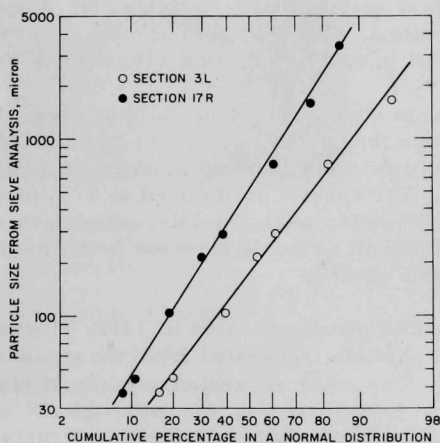
Fig. 81  
Cumulative Size Distribution of Particles

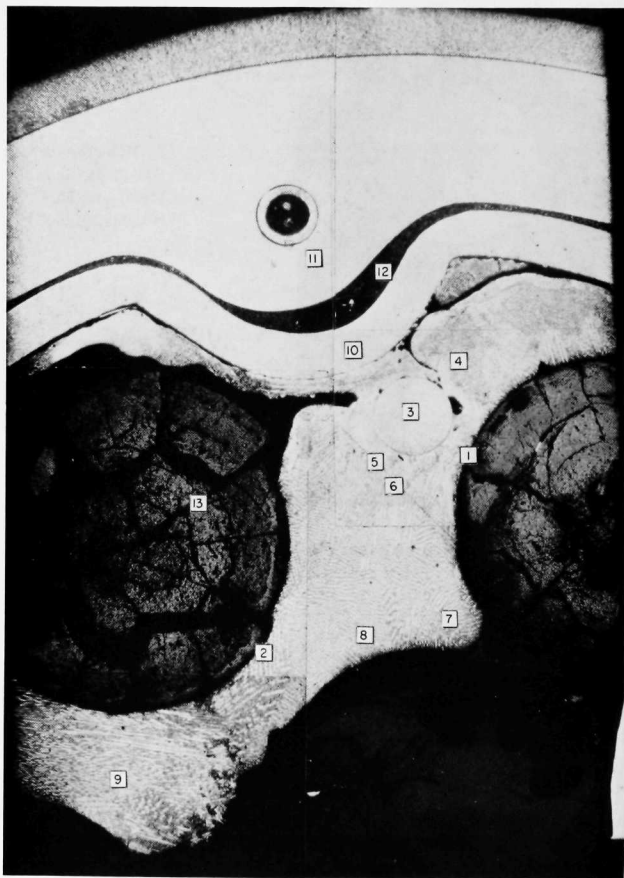
Fig. 83. Section 118A30R2, Showing Locations of Microprobe Analysis. Mag.  $\sim 11\times$ . Neg. No. MSD-181997.

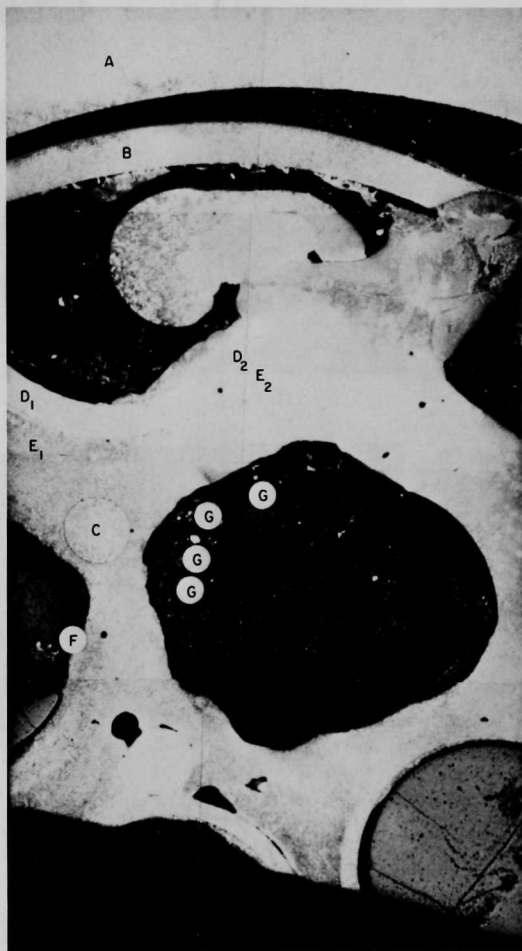
Fig. 84. Section 118A23L2, Showing Locations of Microprobe Analysis. Mag. ~11X. Neg. No. MSD-181996.

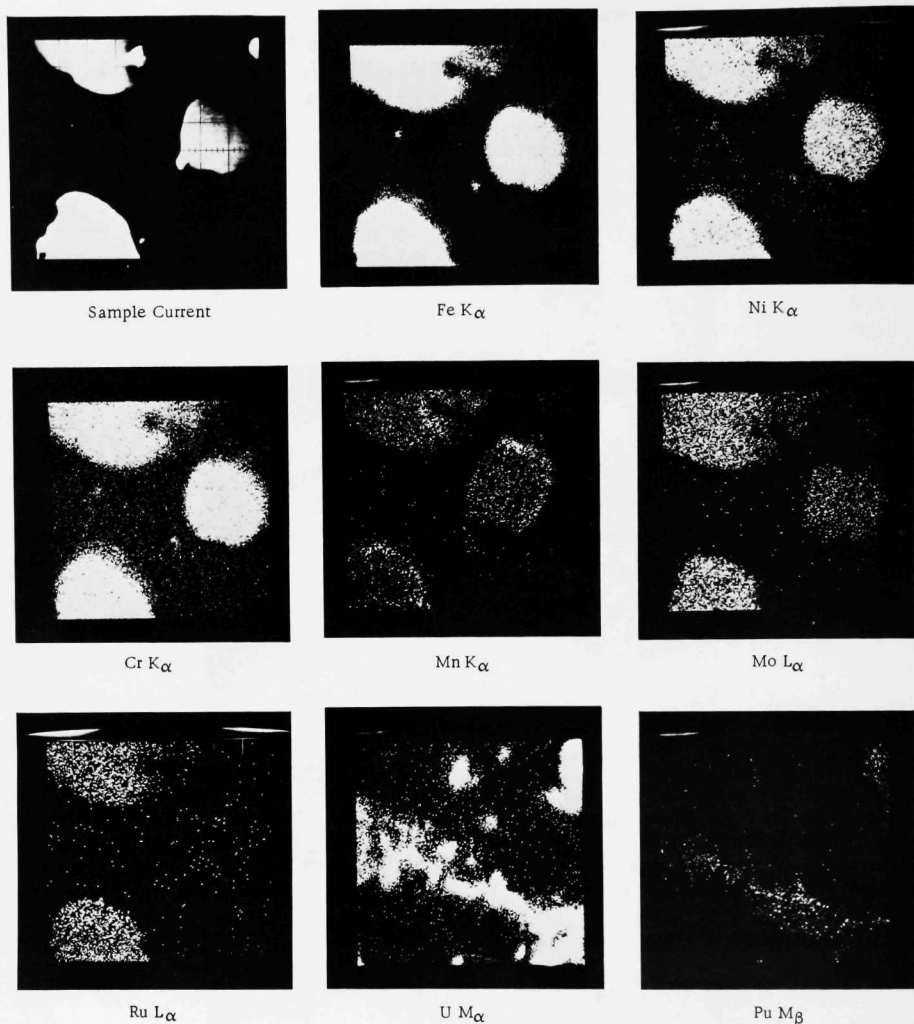
Fig. 85. Sample Current and Elemental Distribution Images of Two Types of Steel Particles from Section 118A23L2. Mag.  $\sim 340\times$ . Neg. Nos. MSD-181991, -181993, -181992, -181994, and -181995.

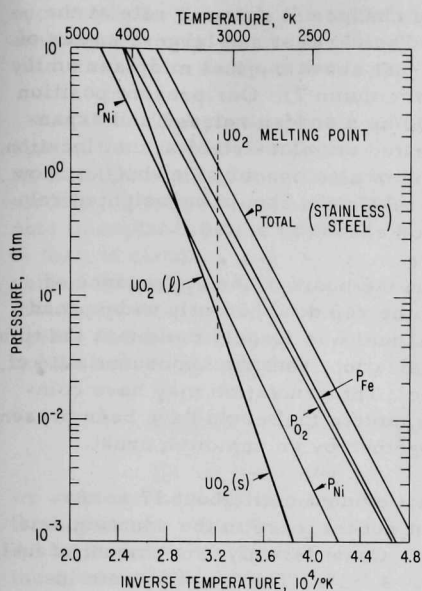
Fig. 87. Vapor Pressures of Fuel and Stainless Steel
